Manhole Inspection Summary

Manhole # S15GG1016MH

Insp Date: **3/1/07 9:30 AM**

Location Address: **4011 DERBY MANOR DR**

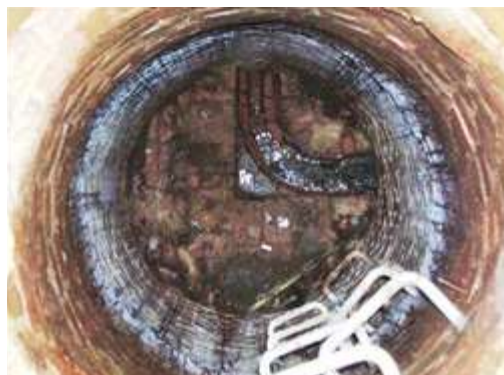
Top View

Evidence of surcharge - Bench debris.

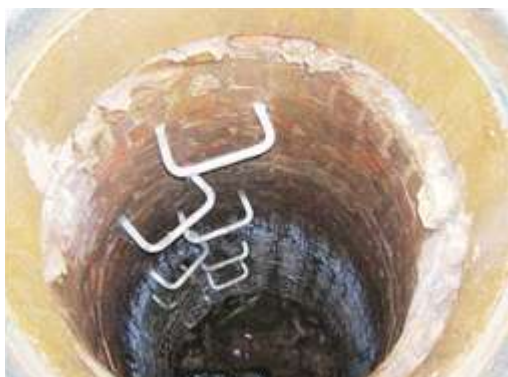
Defect

Frame leaks. Frame offset. Adjustment deterioration, loose brick, and infiltration. Barrel infiltration - other side.

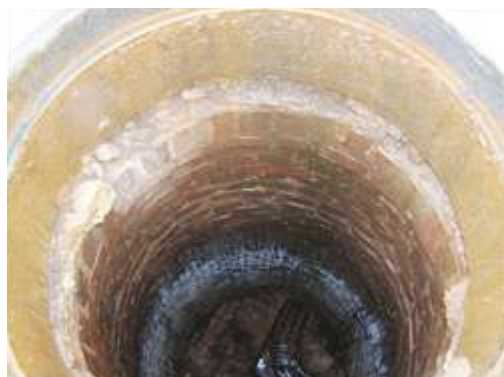
Defect

Frame leaks. Frame offset. Adjustment deterioration, loose brick, and infiltration. Barrel infiltration.

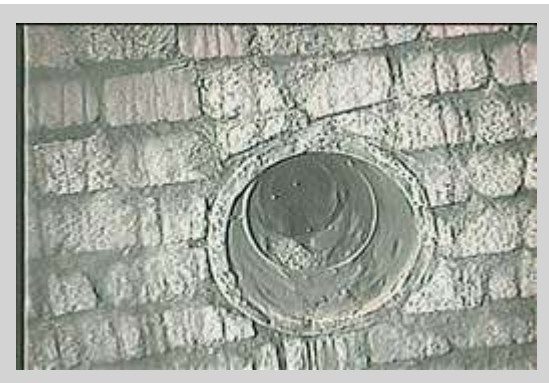
8 in. Circular Gravity Sewer Pipe In @ 3 O'Clock

Infiltration: **Evidence** Pipe Seal Cond: **Unknown**

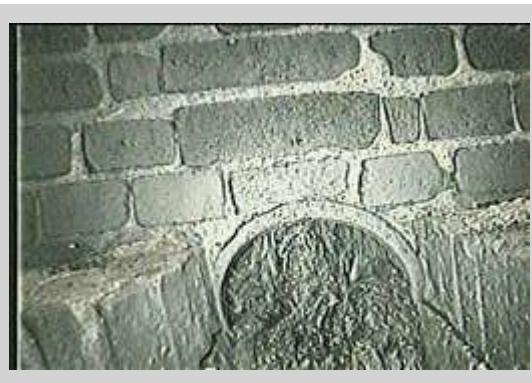
Drop In @ 3 O'Clock

Comments **The I3 Drop ext. pipe has heavy root intrusion inside of it.**

Root intrusion inside of the I3 pipe drop connection. Channel deterioration.

Drop Condition: **Partly Clogged**
